Problems with Waterside Insulation – interrupted gutterline

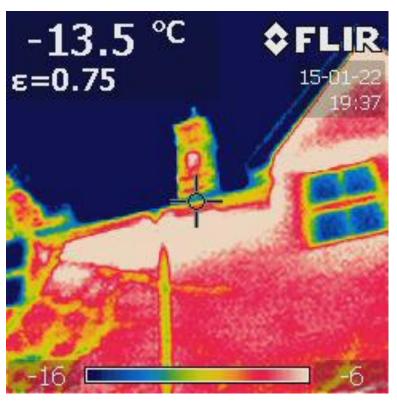
We already knew that the cavity wall insulation is just a couple of sheets of polystyrene, and that houses with dormer windows had very little insulation on the top floor vertical walls, but this survey showed a surprising lack of insulation in the design of house called "Bodleian". This has 3 floors and dormer windows that interrupt the gutterline.

In this thermal image maximum heat loss is shown by white/red colour.

Investigation showed that there was virtually no insulation behind the deep wooden composite beams that support the roof, so there was an area of approx. 8sq metres not insulated at all.

It was not possible to use normal insulation rolls because of the restricted space, so vermiculite was introduced through the narrow space and the area successfully insulated.
